Transmission: 6L Series Subject: Low Line Rise in R, Delayed Reverse Engagement, Slipping, Burnt Clutches Application: GM Issue Date: June, 2015

Transmission: 48RE Subject: Transmission Oil Cooler Line Leak Application: 05-06 Dodge Ram 2500-5500 Issue Date: June, 2015

Transmission: 09G Subject: Missing B1 Clutch Housing Retaining Snap Ring Application: VW Issue Date: June, 2015

Transmission: 4AT Version 2 Phase 2 Subject: Valve Body Layout and Solenoid Function w/ 2 Blue Connectors Application: Subaru Issue Date: June, 2015

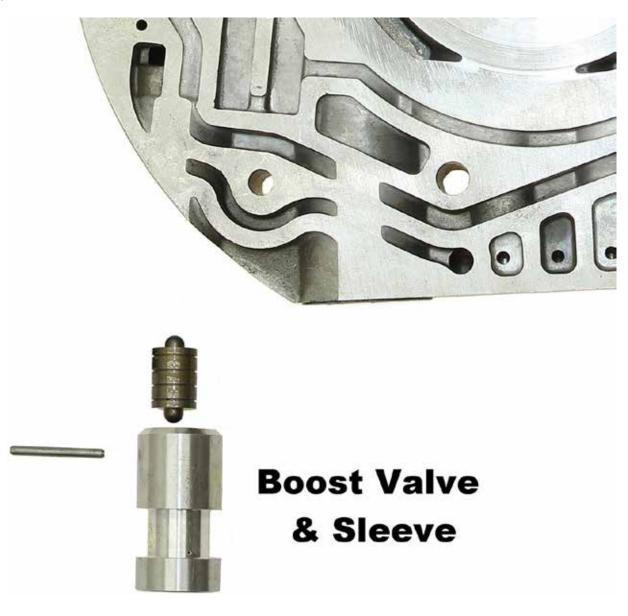
While working on a GM vehicle equipped with a 6L series transmission, you may encounter erratic or low line rise in reverse, delayed reverse engagement, slipping or burnt clutches. These concerns may be caused by a worn boost valve and sleeve located in the pump. Replacing the boost valve and sleeve may repair this concern.

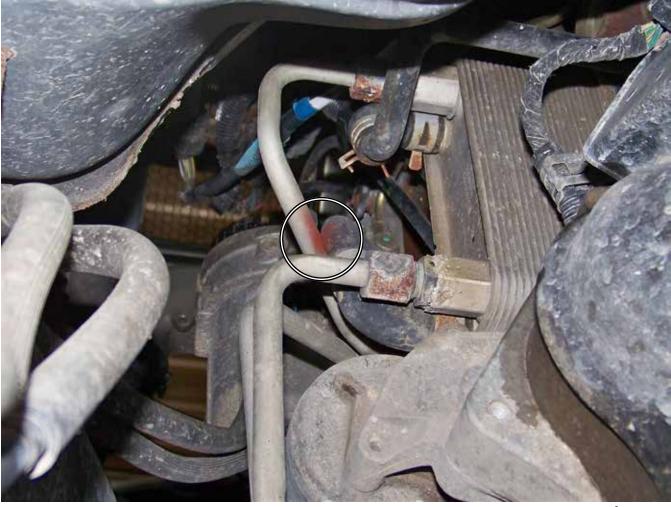
48RE Transmission Oil Cooler Line Leak

While working on a 2005-2006 Dodge Ram R2500-R5500 equipped with a 5.9 D engine and a 48RE transmission, you may notice the transmission converter cooler hose (coolant) resting or rubbing on the transmission converter cooler line (hydraulic) (Figure 1). Allowing the converter cooler hose to rest or rub on the converter cooler line may cause a leak in the cooler line. It would be recommended to reposition the converter cooler hose away from the cooler line and insulate the cooler line to prevent further damage (Figure 2).

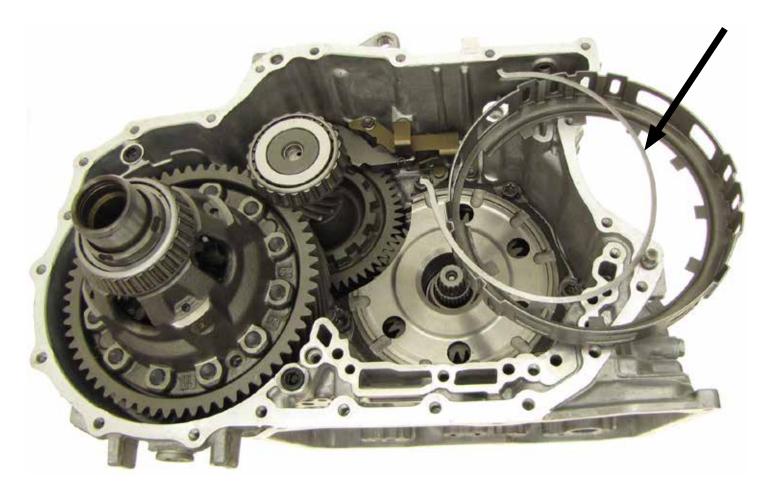
In the past there have been a number of inquiries concerning a missing B1 clutch housing retaining snap ring in various Volkswagen models equipped with the 09G transaxle. We have seen a number of these vehicles in shops where upon disassembly there is no B1 clutch housing retaining snap ring.

Upon closer inspection of the B1 clutch housing setup, the technician will notice the snap ring does not effectively retain the B1 clutch housing in the transmission, and is not necessary for normal operation. A good rule of thumb is to reuse the snap ring if it was installed in the transmission and found during disassembly and to leave it out if there was no snap ring installed. Refer to the figure below for identification and location of the B1 clutch housing retaining snap ring.

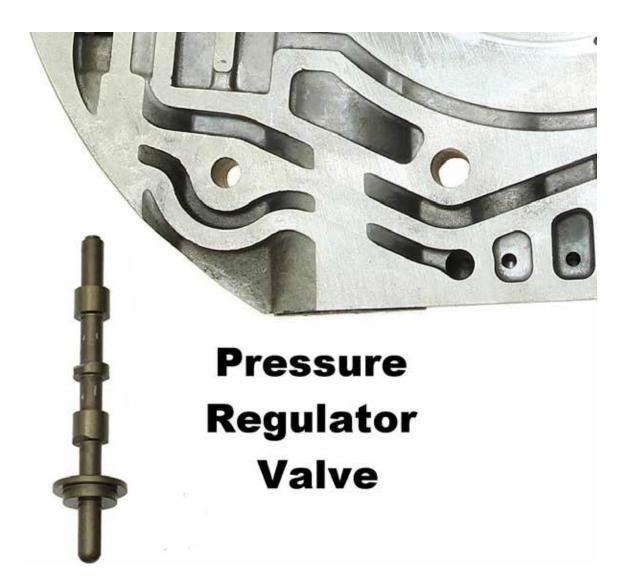
While working on a G.M. vehicle equipped with a 6L series transmission, you may encounter erratic line pressure, slipping, burnt clutches transmission overheating concerns. These concerns may be caused by a worn pressure regulator valve and bore located in the pump. Replacing the pressure regulator valve located to repair this concern.
