Transmission: 6L Series Subject: Low Line Rise in R, Delayed Reverse Engagement, Slipping, Burnt Clutches Application: GM Issue Date: June, 2015

Transmission: 48RE Subject: Transmission Oil Cooler Line Leak Application: 05-06 Dodge Ram 2500-5500 Issue Date: June, 2015

Transmission: 09G Subject: Missing B1 Clutch Housing Retaining Snap Ring Application: VW Issue Date: June, 2015

Transmission: 4AT Version 2 Phase 2 Subject: Valve Body Layout and Solenoid Function w/ 2 Blue Connectors Application: Subaru Issue Date: June, 2015

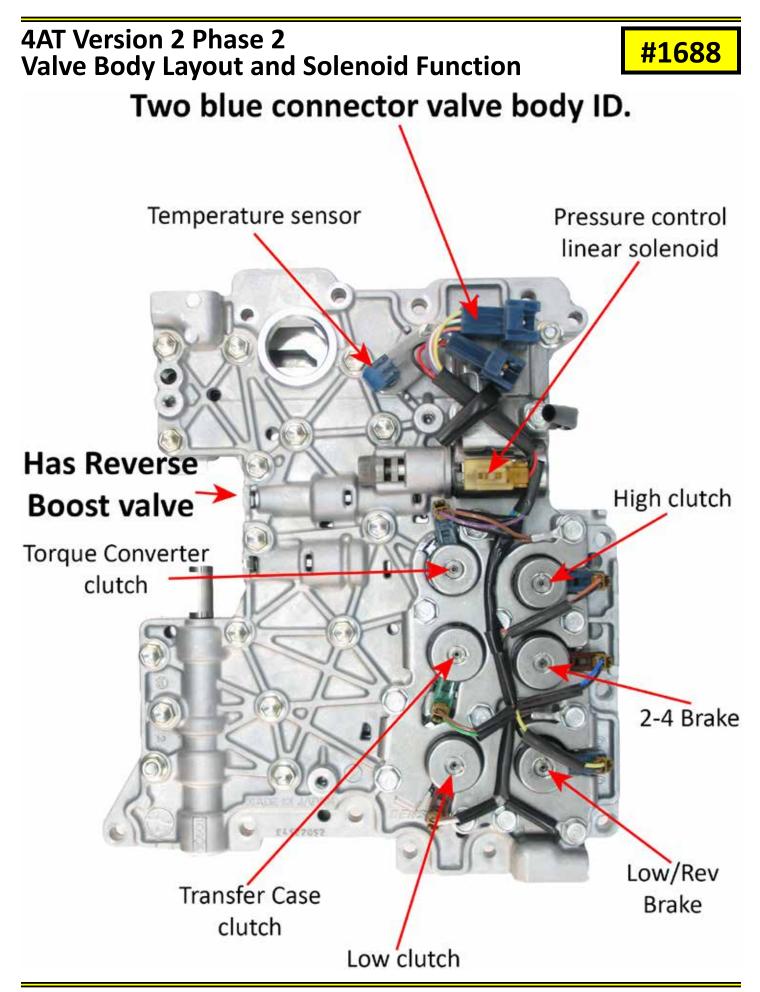
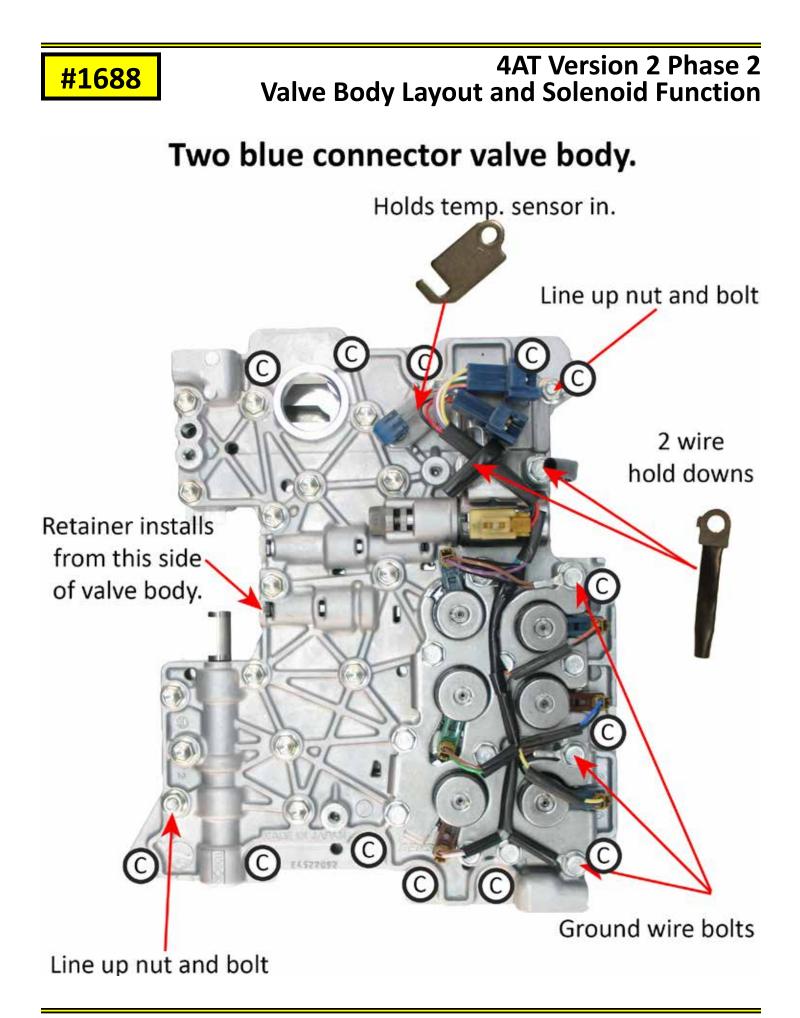
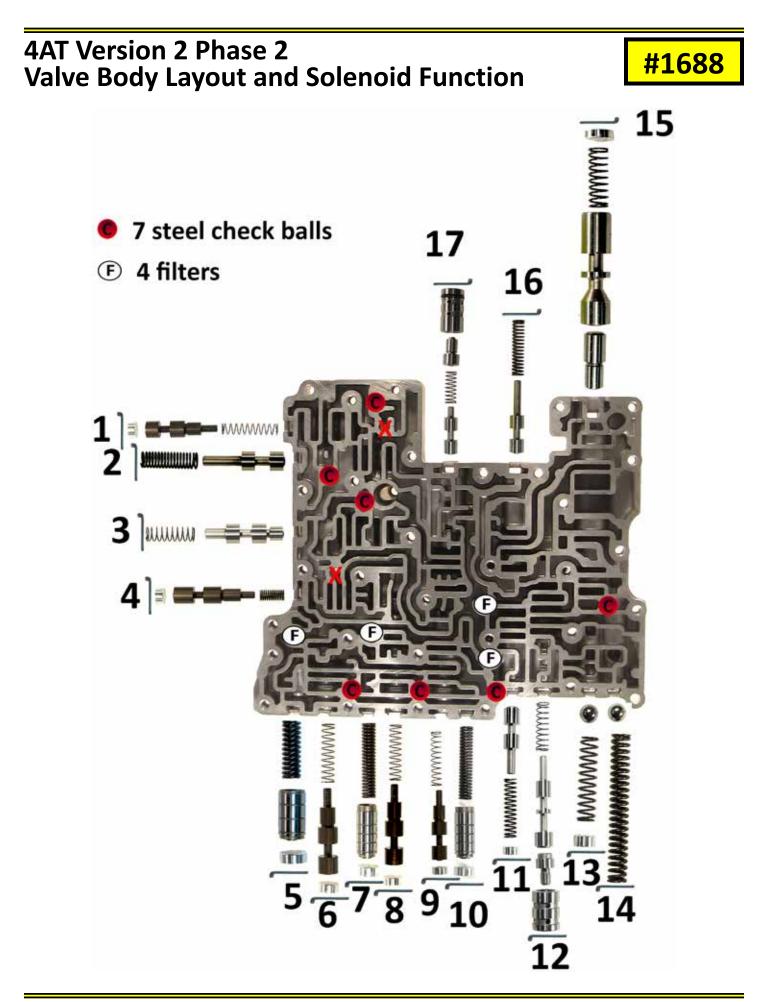
The first step is to ID the valve body by the solenoid main connector. There are three different styles of connectors: single black, 2 blue and 2 red. Special Thanks to Perfection Plus Transmission Parts.

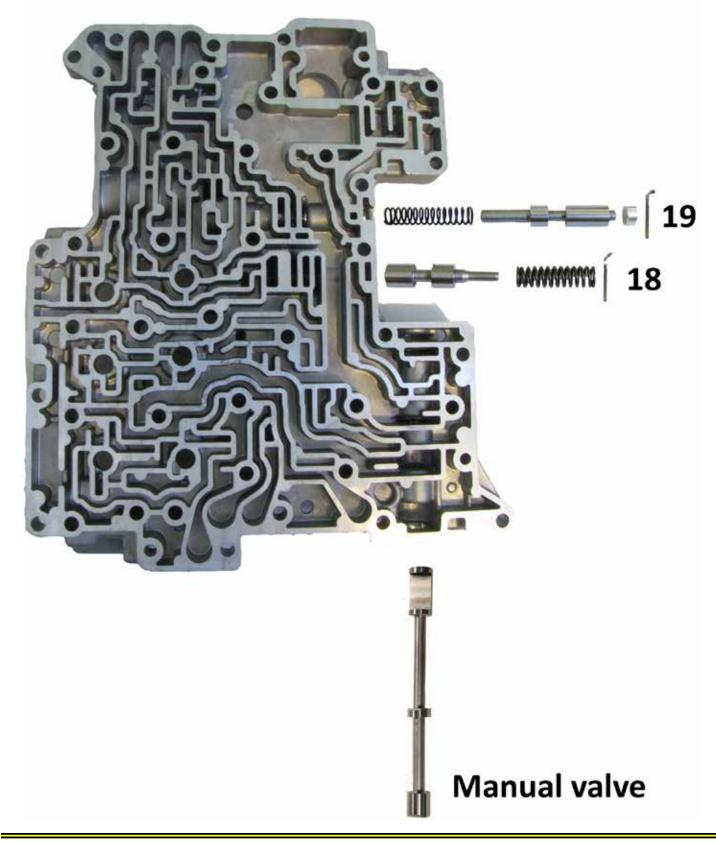
4AT Version 2 Phase 2 Valve Body Layout and Solenoid Function 2 Blue connector lower valve body.

Bore # **Valve Function Free Length Outside Diameter** Wire Size 1 Low/Reverse 1.548" 0.329" 0.021" 1.45" 0.36" 2 Low/2-4 0.045" 0.031" 3 Low/Reverse 1.258" 0.354" **Transfer Clutch** 0.601" 0.304" 0.026" 4 5 Low Accumulator 1.142" 0.062" 0.338" 6 1.35" 0.328" 0.021" Low Clutch 1.645" 0.321" 0.052" 7 2-4 Accumulator 8 2-4 Brake 1.276" 0.326" 0.021" 9 1.55" 0.329" 0.021" **High Clutch High Accumulator** 10 1.648" 0.322" 0.052" 0.331" 0.034" 1.425" 11 Lock-up Lock-up 12 1.194" 0.354" 0.031" 1.514" 0.354" 0.039" 13 Lube limit (.343 ball) 14 2.693" 0.374" 0.061" Line limit (.343 ball) 15 **Pressure Reulator** 1.364" 0.431" 0.046" 16 TCC/Lube 1.665" 0.352" 0.052" 17 2-4 Brake 1.027" 0.35" 0.031" 18 Pilot 1.154" 0.353" 0.045" 19 **Reverse boost** 1.884" 0.36" 0.041"

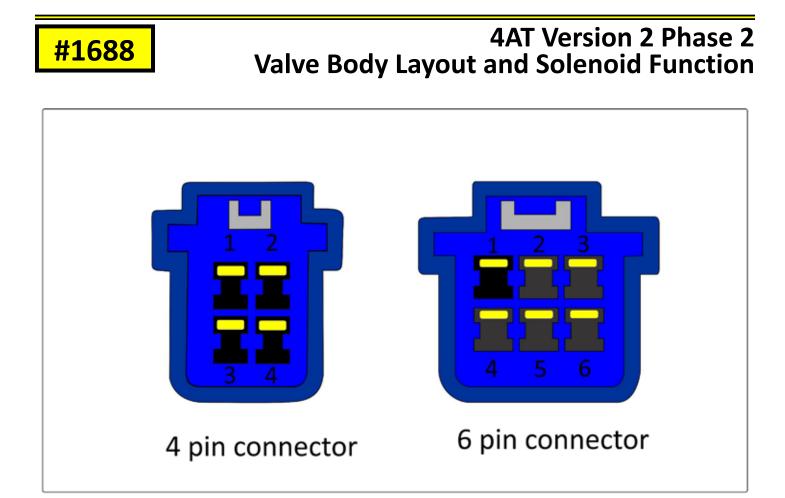
Solenoid/sensor	Connector	Pins	Ohm's
Temp. sensor	4 pin connector	2 & 4	4.3 @ 70F
Pressure control	4 pin connector	1&3	4-8 Ohm's
High clutch	6 pin connector	1 & ground	2-6 Ohm's
Low clutch	6 pin connector	2 & ground	2-6 Ohm's
Low/Rev clutch	6 pin connector	3 & ground	2-6 Ohm's
2-4 Brake	6 pin connector	4 & ground	2-6 Ohm's
Transfer clutch	6 pin connector	5 & ground	2-6 Ohm;s
TCC clutch	6 pin connector	6 & ground	2-6 Ohm's

The Pressure Control Linear solenoid controls oil flow and pressure to the spring side of the Pressure Regulator valve to provide line raise.

The Pressure Control Linear solenoid has 4-8 Ohm's.

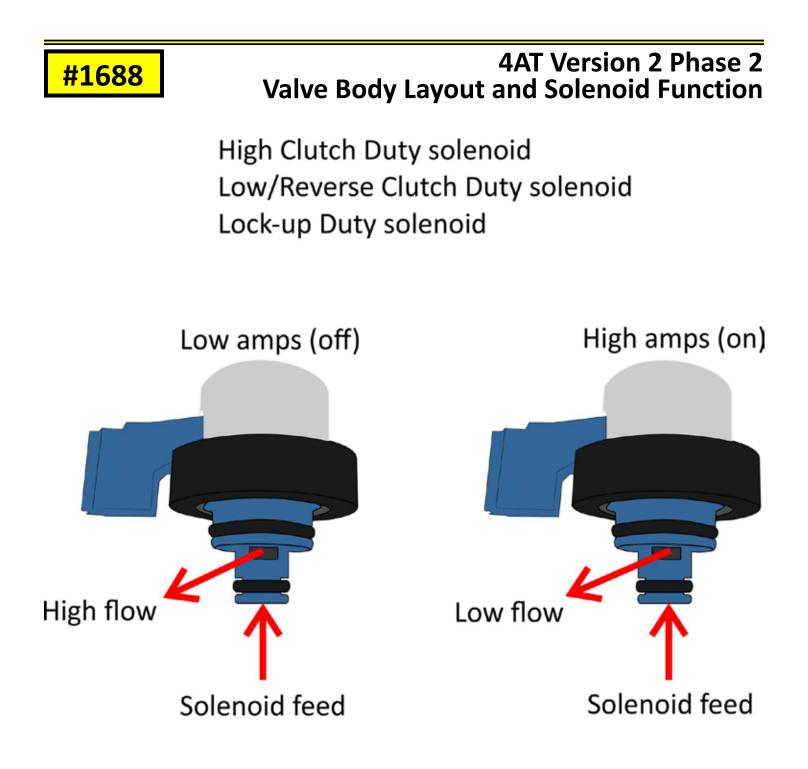
These solenoids are high side driven and the ground side is connected to a bolt on the valve body.

Solenoid has 2-6 Ohm's

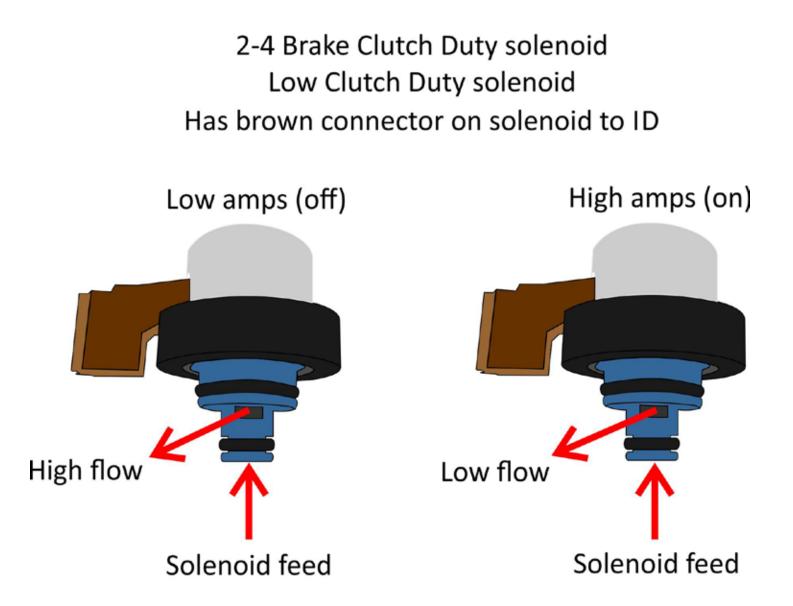
These solenoids are high side driven and the ground side is connected to a bolt on the valve body.

Solenoid has 2-6 Ohm's

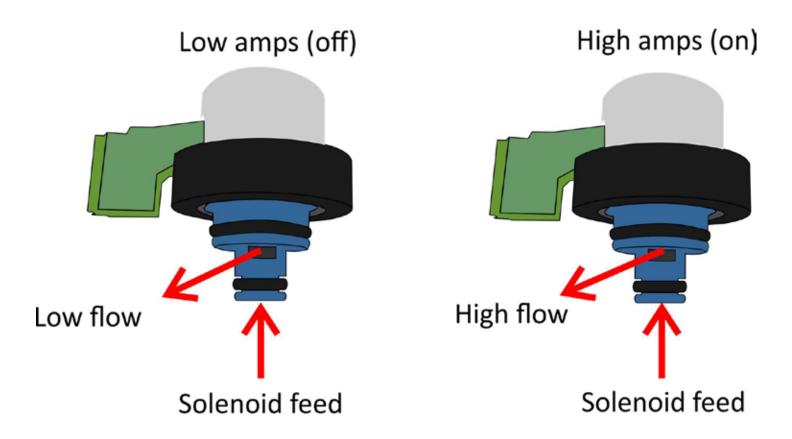
Transfer Case Clutch solenoid Has green connector on solenoid to ID.

These solenoids are high side driven and the ground side is connected to a bolt on the valve body.

Solenoid has 2-6 Ohm's
